Manhole Inspection Summary

Manhole # **S19K__018MH**

Insp Date: **10/4/07 11:13 AM**

Location Address: **2026 PRATT-FREDERICK**

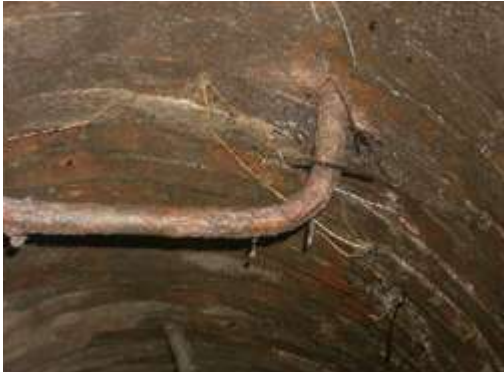
Defect 2

Condition: ☐ Sound ☐ Cracked ☒ **Root Intrusion** ☐ Loose Brick ☐ Deteriorated

ROOT INTRUSION ON CORBEL

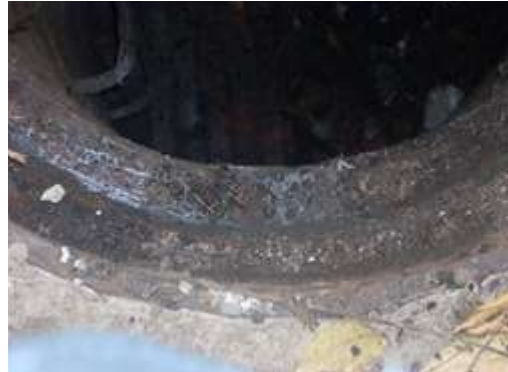
Defect 1

Offset: **2** (in.)

FRAME OFFSET

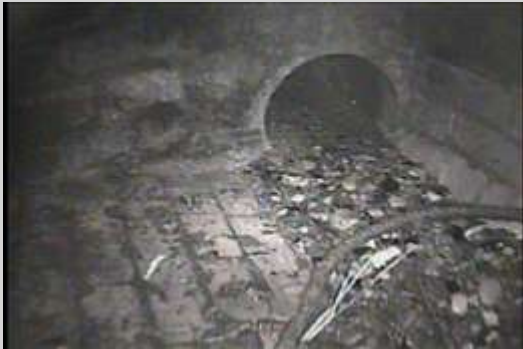
12 O'Clock Outflow

8 in. Circular Gravity Sewer
Pipe Out @ 12 O'Clock

Deposits: ☐ None ☐ Mud ☐ Sludge ☒ **Debris** ☐ Grease

Silt Depth: **1** (in.) Deposits Extent: **Light**
